**ADDENDUM REPORT ON THE CONDITION OF THE  
SURVIVING STRUCTURAL FABRIC  
FOLLOWING THE FIRE  
(POST INVESTIGATION)  
ST PETER'S CHURCH  
ROPLEY**

**FOR THE ROPLEY  
PAROCHIAL CHURCH COUNCIL**

**REPORT: 7151:02  
DATED: November 2015**

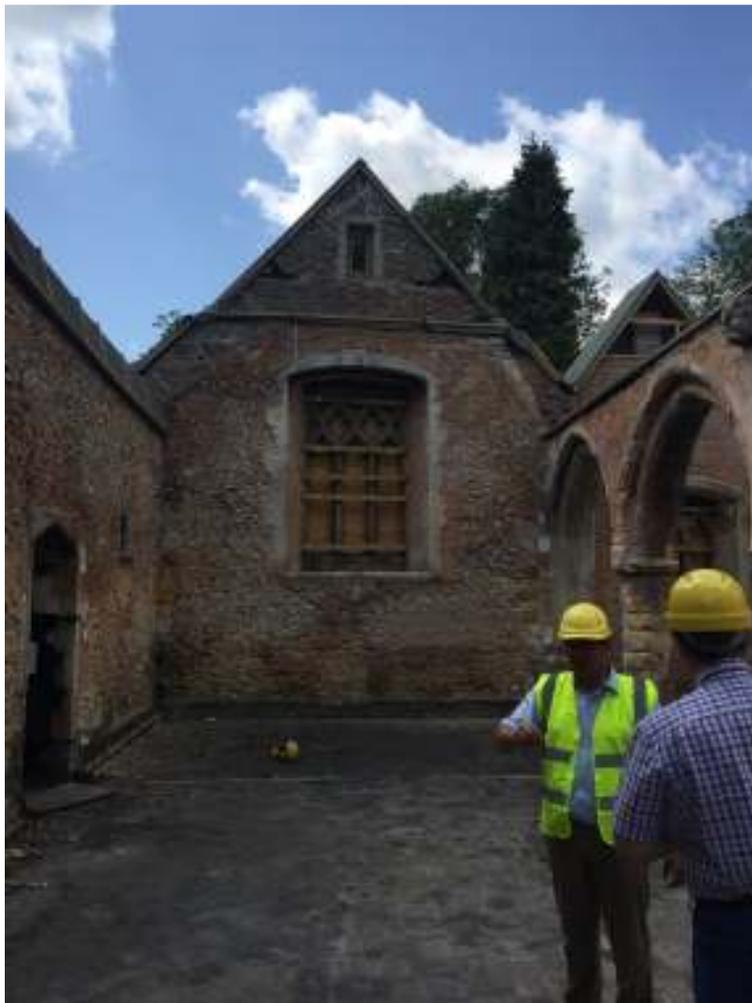
#### **View Of Nave Section of the West Wall**

The West wall was further examined by excavating a hand dug trial pit internally - test pit 8 and externally – test pit 6. The foundations of the building were exposed and recorded and the underlying strata were assessed.

The foundation to this wall revealed a flint base internally in the south-west, and a concrete footing externally at this point. It is clear that the west elevation has been re-faced in the past, and the corner buttress added, suggested to be during the Victorian extension and re-modelling when the brick and flint faced walling of the north extension was also built. The outer face of the earlier nave was over skinned, being built off a concrete footing.

The west wall construction above the slab was investigated. The wall was visually identified as having been damaged by the fire, more probably by the sudden quenching of the extinguishing of the fire in fact, which has caused visible widespread and fracturing of the embedded flint and exfoliation of the cob matrix at the surface. Cracks in larger flints were found to be of 150mm depth into the wall, and cob in the region of 50mm deep was found to be very friable.

Further examination at height and opening up of the wall over an extensive area confirmed that this fracture damage to the flint and friable failure of the cob matrix is virtually the full surface area of the nave west wall has been affected.

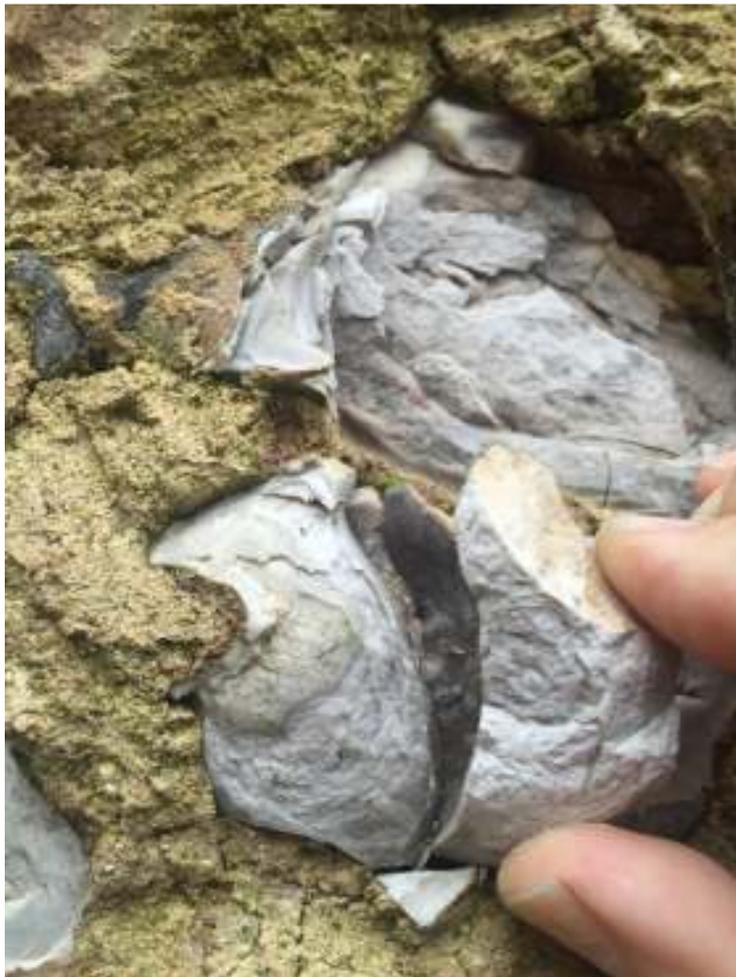
**View of Fractured Flint in West Wall**

A hole was completely excavated through the wall to examine the interface of the later Victorian flint facing externally. This was in fact confirmed as a facing, and found to be solely of flint, no evidence of ferrous tying was found to the original gable wall. The overall wall thickness, including the Victorian flint facade was found to be in the order of 850mm.

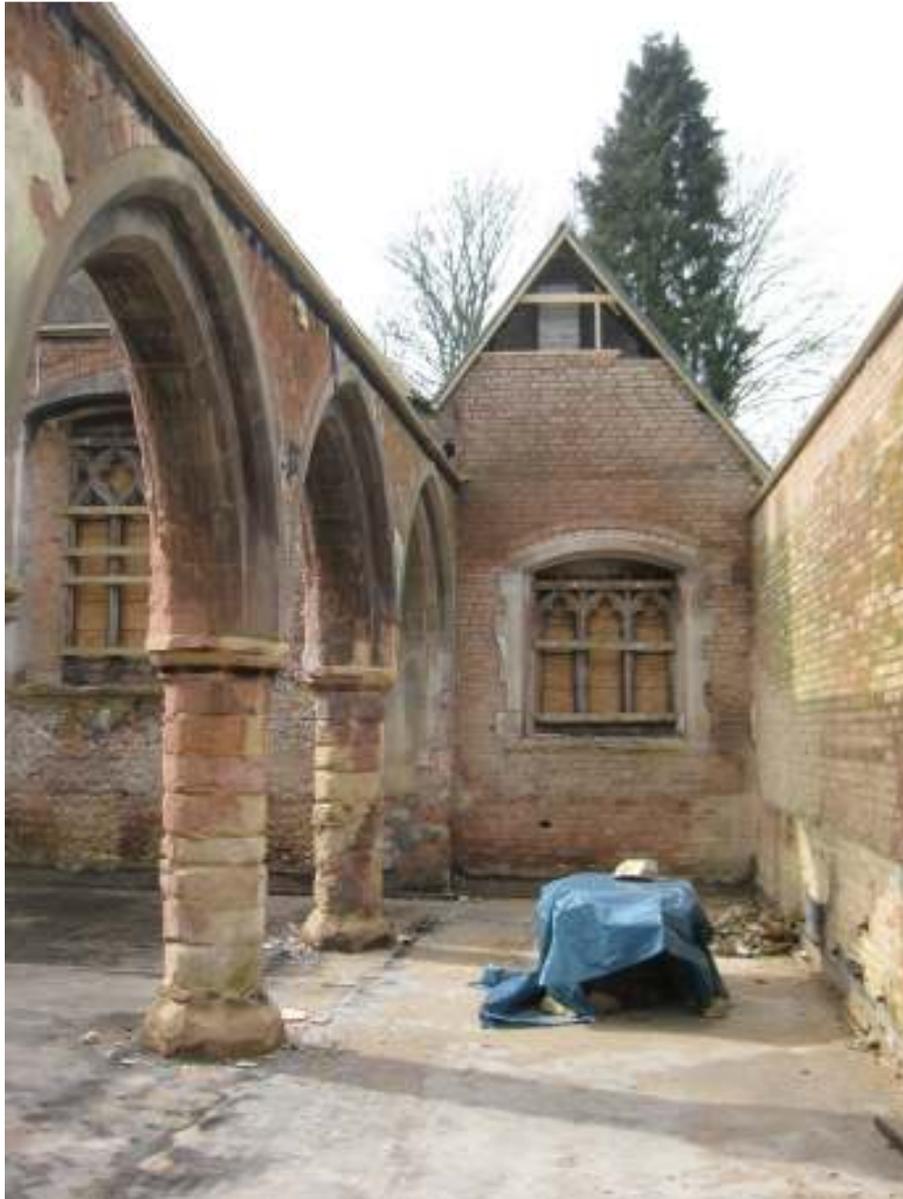
#### View Of Aisle Section of the West Wall

The aisle section of the West wall was further examined by excavating a hand dug trial pit internally - test pit 9, and externally – test pit 7. The foundations of the building were exposed and recorded and the underlying strata were assessed.

The foundation to this wall revealed a concrete footing, bearing into chalk but the depth of which could not be fully determined due to the presence of fractured and disturbed human remains.

The wall construction above the slab was investigated and confirmed as clay brickwork with an external flint facing, and this has largely survived the effects of the fire intact, without significant structural damage.

The internal decorative hard plaster had detached as a result and this has been removed.

The wall appears to be able to be preserved in the fabric of any new proposal, subject to the applied load and resulting foundation pressures.

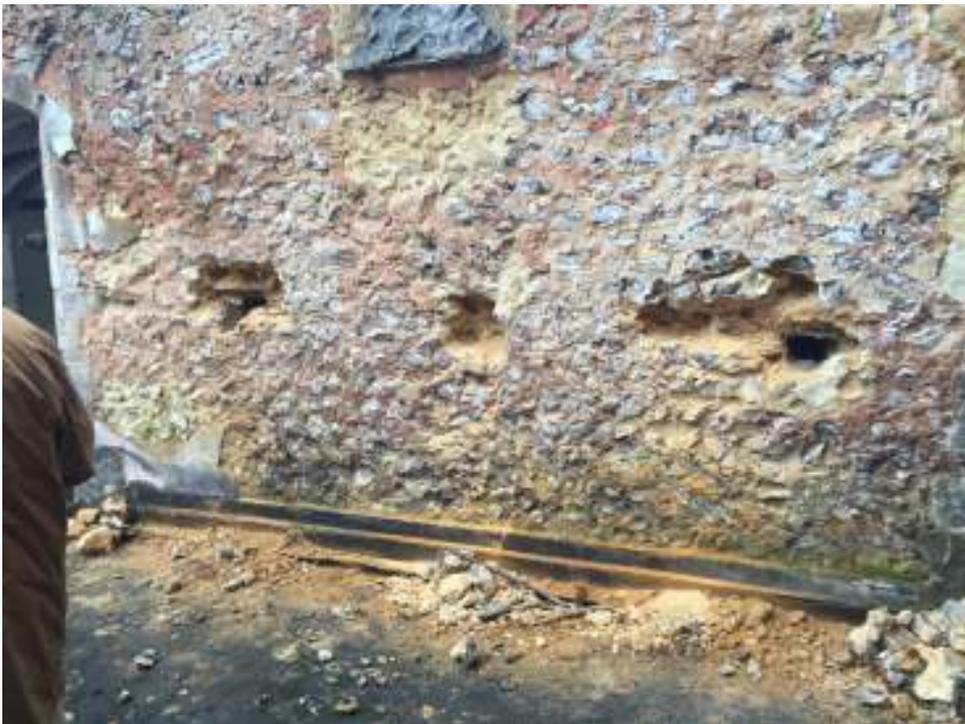
#### **View of Western Lower Section of South Wall**

The south wall was visually observed to be damaged by fire in a similar manner as the west wall; cracking in the flint and widespread friable cob matrix damage. This was investigated in

a similar fashion to the west wall by opening up and exposing the flints to approximately 300mm depth. Cracked flints were found and the cob matrix friable to 50-75mm depth.

It was concluded immediately after this stage of the investigation that the wall surface on the south and west walls would have to be repaired, since the cracked flint and unstable surface are considered unsatisfactory.

The extent and depth of the cracked flint would in my opinion make the wall structurally unstable, the strength of the wall being reduced by at best 150mm and at worst 225mm depth – thus rendering it 40% weakened.

The friable cob matrix damage will also lead to gradual wall decay/erosion if left, and the inability to apply any decorative surface to a satisfactory standard would be unsatisfactory

A decision was made at this point to try and determine a repair strategy for the wall face and to then test this in situ. A variety of attempts were made to install a stainless steel twisted wire tie into the cob matrix, expecting that this would be satisfactorily anchored to resist a pull out load, so that a new flint and cob facing might be bonded to the unaffected core of the wall.

In my opinion therefore, if the wall fabric generally is as found in the opening up holes, it is possible that the west and south nave wall could be repaired and retained. If the fabric of the cob is however found to be unable to accept a tie, and a pull out test, an alternative solution will need to be found.

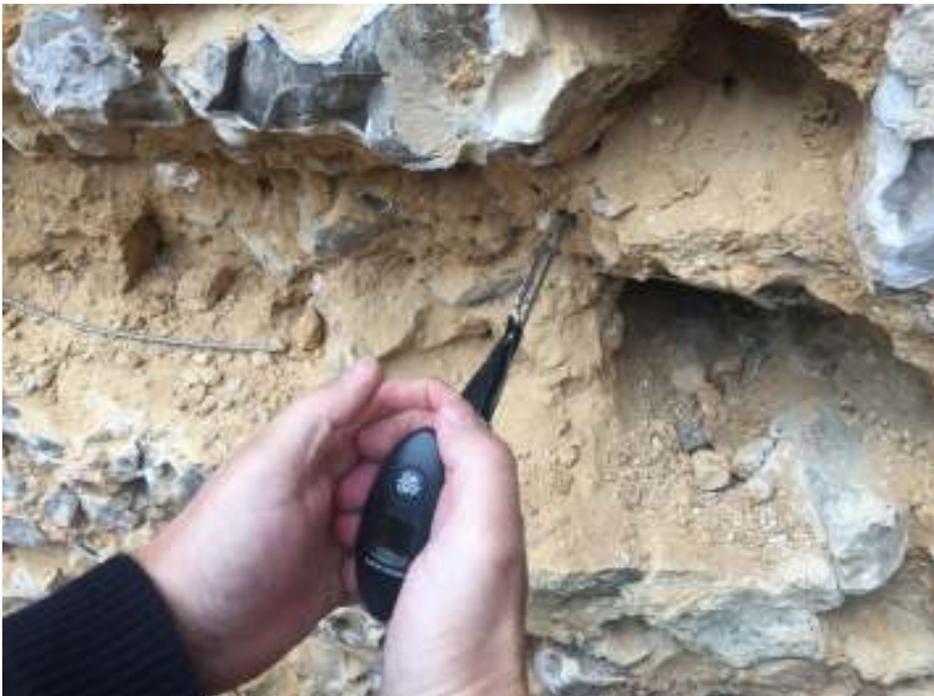
**Photograph of Wire Tie and Pull Out Test**

Driving the tie into the cob was un-successful. Drilling a pilot hole was successful after four attempts, and applying a resin grout into the hole allowed the twisted wire to be adequately anchored,. The wire tie resisted a pull out load in the order of 40kg and when a suitable safety factor was applied this would be adequate.

Clearly, the success or otherwise of such a installation does rely upon being able to drill a pilot hole through the random flint/cob matrix, but it is considered possible that this could be achieved in any process of repair, however this is of course assuming that the wall fabric is as found in the opened up[ locations which may not of course be widespread.

The fact that the actual position of such ties is not critical, either visually or from an engineering perspective suggests that it could be successful as a strategy. This would enable the wall to be repaired and successfully utilised in retention of this element of the fabric in any proposed re-construction.

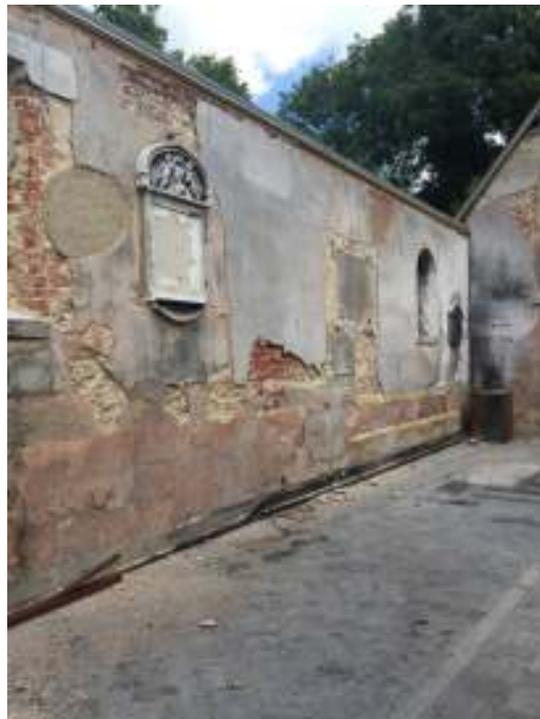
**Photograph of Eastern Section of North Wall**

There are elements of brick where a window has been infilled and the height of the wall raised as part of the Victorian re-modelling.

The wall has been affected to a much lesser extent by the fire. Damage has been restricted to plaster becoming loosened which has since detached.

Foundations to the wall were exposed in test pits 1 – externally on the eastern end and 9 internally. Opportunities for more extensive exposure were restricted by a grave mid-length and a lean to structure nearer the eastern end.

However, on the Victorian wall section, the concrete footing similar to that found on the south wall in pit 7 was again confirmed as being of concrete, extending to some depth, but the full extent could not be confirmed due to the presence of disturbed human remains.

The foundation and wall is considered adequate to re-support future loads with the proviso that the magnitude of such loads and method and location of application does not change significantly.

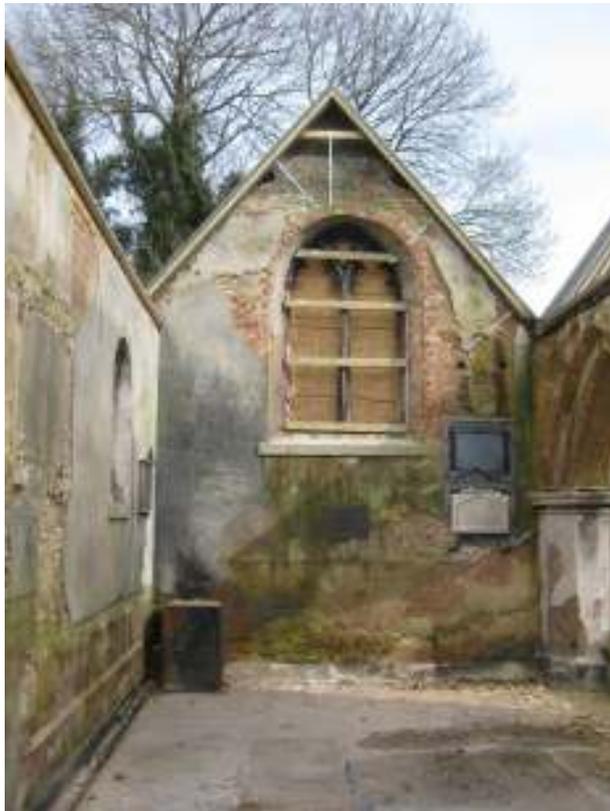
**Photograph Of Part of The East Wall**

The East wall foundations were exposed in pit 2 externally to the north, and mid length externally in pit 3. In both cases the wall was founded directly on chalk strata at some depth. This area of the church fabric was dug into the site and hence the competent soils have been used as a founding material

The wall has not been affected by any significant extent by the fire; however the wall is in poor condition, having a distinct outwards eastern lean.

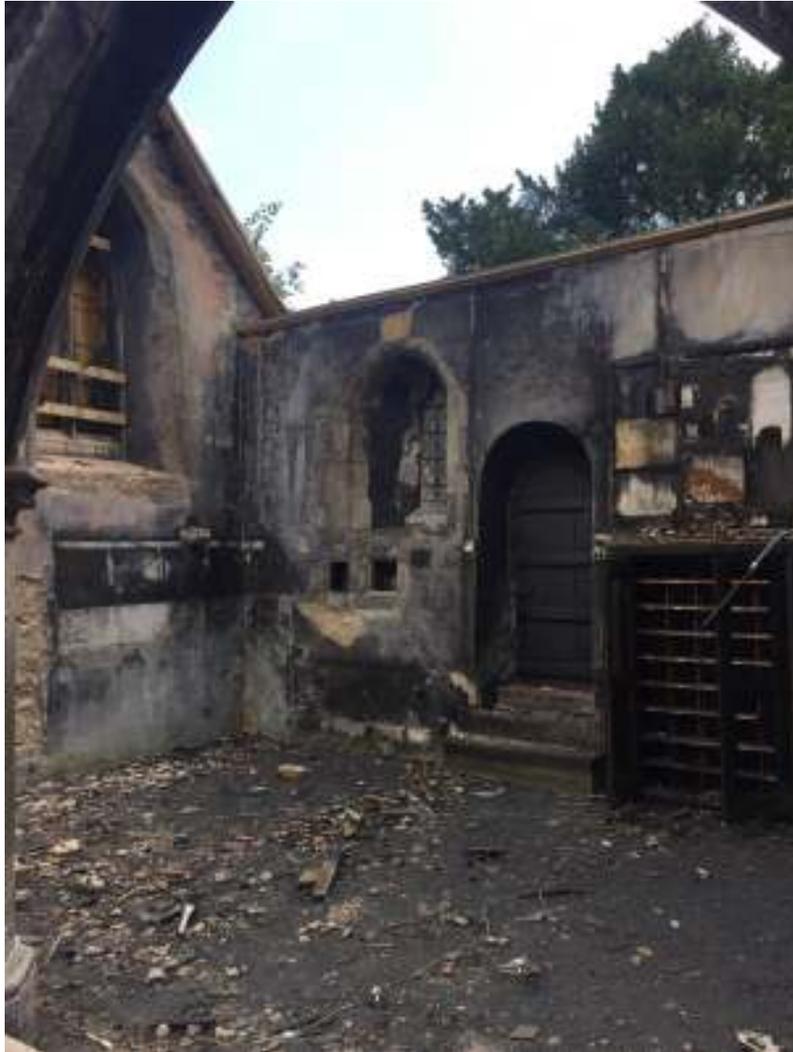
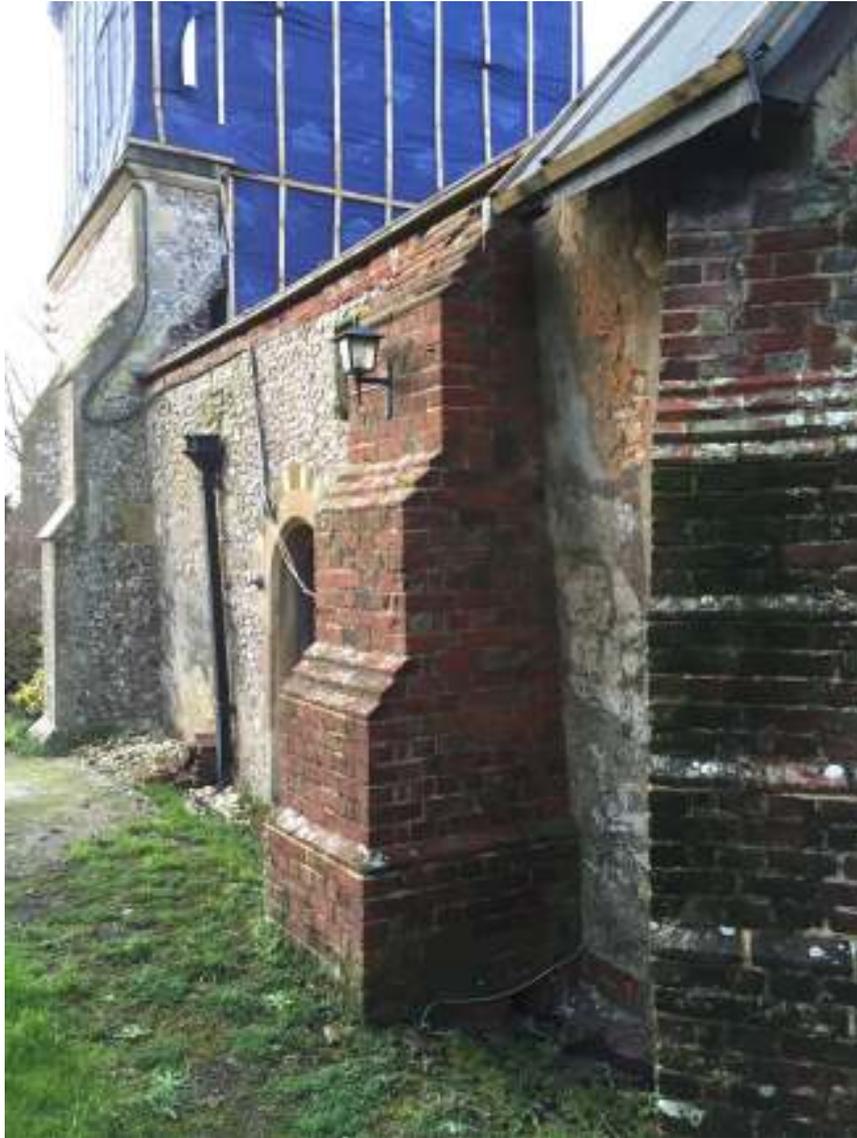
The south east corner buttresses and 13<sup>th</sup> century eastern section of the south wall are both in very poor condition, expressing vertical and lateral distortions and significant out of plumbness. The wall was measured as being 350mm out of plumb at the old eaves level. The foundations to the corner buttress were exposed in pit 5 and found to be founded on silt. Test pit 4 exposed the south wall base which was found to be supported on a silty clay. Both foundations are shallow and fully account for the historic distortions and current movements demonstrated in the upper wall sections.

**View Of The East Section of the South Wall**

**View of The East Section of South Wall Externally – Showing Out of Plumbness**

It is clear that the wall and foundation cannot be relied upon to support with any confidence at all, any new fabric, and this section should be carefully taken down and rebuilt on a reliable footing. Underpinning of the wall would involve a significantly greater excavation and result in solving only part of the structural problem of this section of the building. The

out of plumbness is considered significant and such that any future roof load that is re-applied would require support independent of the existing wall fabric.

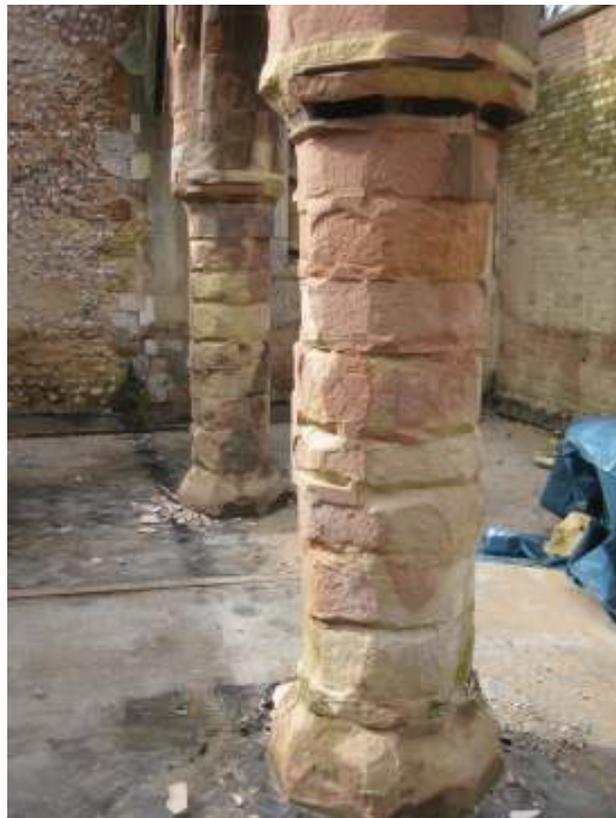
#### **Photograph of Nave North Aisle Pillars**

The north aisle nave arches and pillars are constructed of natural stone and have been very badly affected by the fire. In my view they are sited very near the probable seat of the fire and given their slender dimensions were heated to elevated temperatures and cooled in reverse equally comparatively rapidly. The stones are universally damaged by cracking.

The extent of the visual cracking in all of the the pillars was probed and found to be quite extensive, in some cases 170mm deep and much of the surfaces exfoliated in quite thick slabs in the order of 30-40mm thick.

In my opinion these arches and pillars cannot be relied upon in any way and are considered to be almost of a dangerous nature in their current condition. I do not consider that they can be repaired insitu or refaced. In my opinion they should be carefully taken down.

It is possible that any new proposal may wish to improve upon sight lines, this being a current relevant topic in modern ecclesiastical buildings, and it may prove possible to span this aisle with a single girder as an alternative, given that the span is supporting roof load only and in the region of 12m.

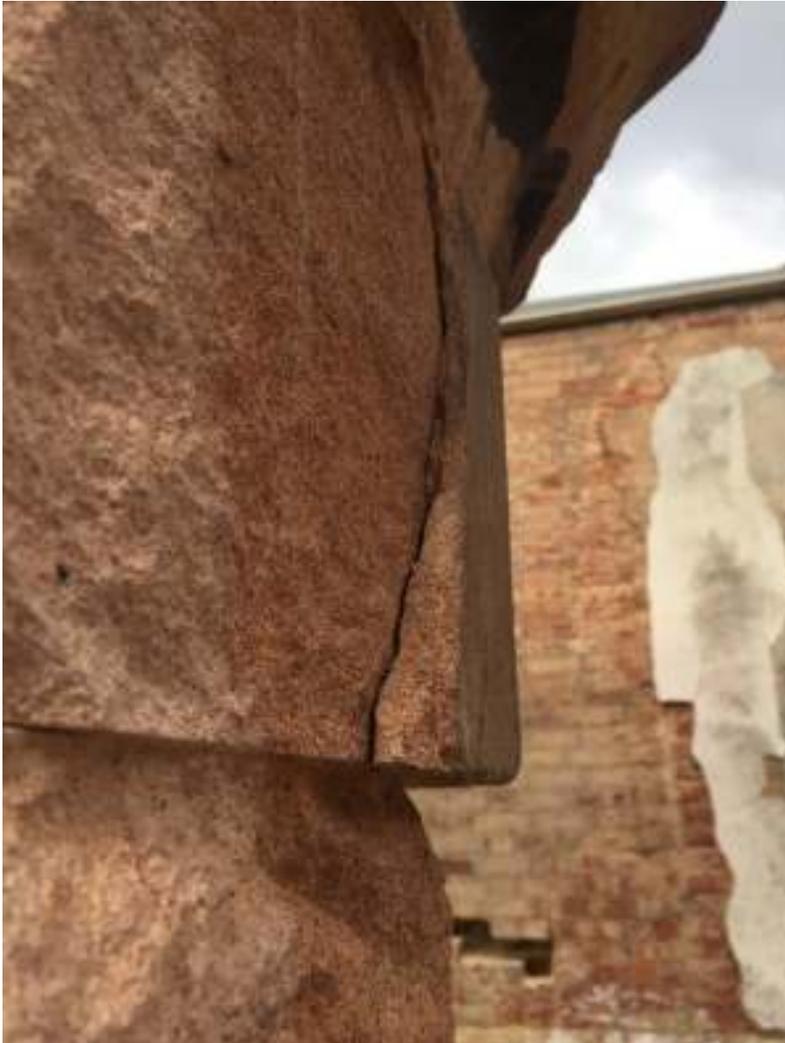
### **Photograph of Pillar Damage**

The arches above the pillars are formed in a natural stone voussoir with brick above. The arches have been extensively damaged, with significant spalling being apparent in all cases.

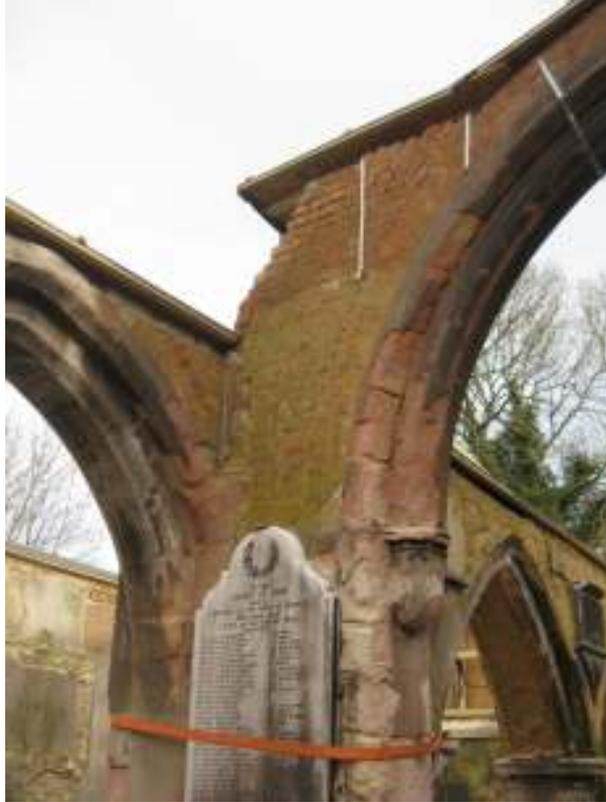
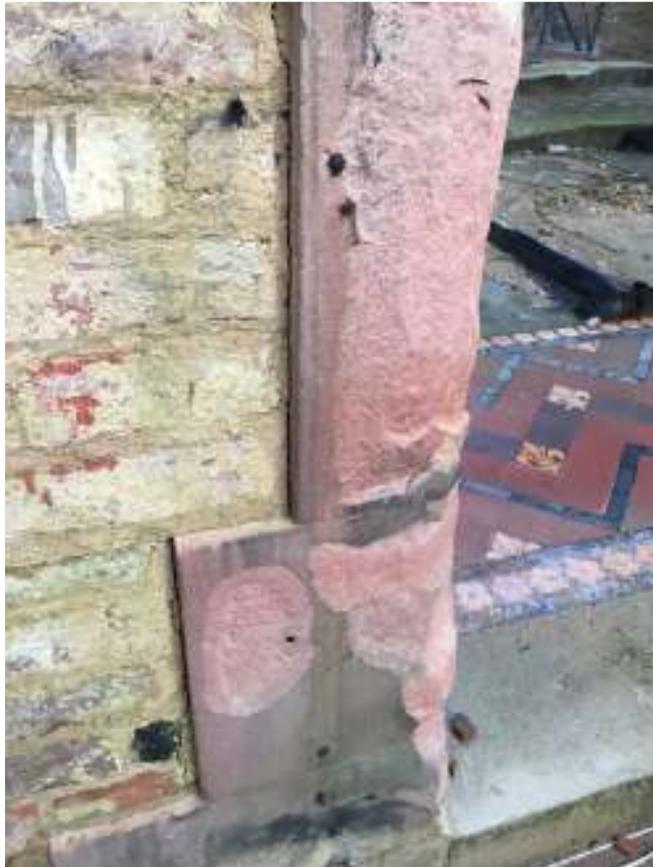
**Photograph of Chancel Arch – North Side**

The chancel arch has been significantly damaged by the fire which has caused extensive spalling, penetrating such that not only the decorative surfaces have been damaged, but the integrity of the arch and the base corbel support too.

The brick support buttress and pillar on the north side are however less affected, due partly to its bulk and the fact that brick and protective plaster have not been adversely affected.

However there is some minor evidence, expressed as cracking in the inner faces of the pillar, that the chancel arch thrusts may be currently causing rotational movement of the support column northwards.

In my opinion the arch and support pillar requires a very significant amount of repair work, both to the stone quoins and brickwork.

It is unlikely that this repair work can be carried out insitu and dismantling significant sections of the arch and pillar will be required to make a successful and meaningful robust repair of this part of the fabric.

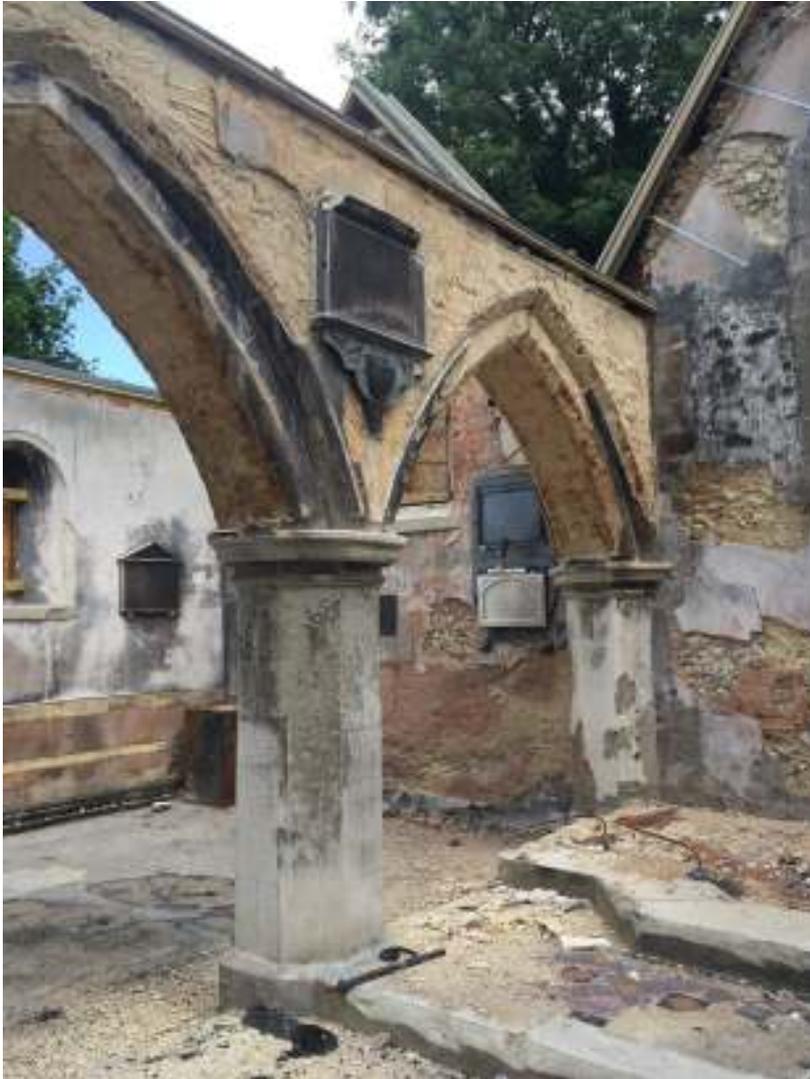
#### **Photograph of the Chancel Aisle Pillars and Arches**

The chancel aisle pillars are of rendered/plastered brick. The pillar elements of the aisle appear intact and to have not been significantly affected by the effects of the fire, the plaster whilst damaged by cracking has afforded some shielding.

However the brick arches have been adversely affected by the intensity of the fire; presumably because of their closer proximity to the roof structure. The intensity of the heat has caused the plaster to blow on the arch faces and soffite, and the brickwork has been damaged on the exposed surfaces throughout. There is a significant fracture at the crown of the most eastern arch which clearly passes all the way through the arch thickness.

It is clear that the structural integrity of the arches have been adversely affected.

Given that the nave aisle arches, the chancel arch and the chancel aisle arches have been adversely affected by the fire and their structural integrity required significant repair, there is clearly a significant question to be considered regarding their overall relationship and mutual support during any repair strategy. The individual arch thrusts will need to be considered during any repair process and the out of balance forces will require extension temporary vertical, lateral and tying support.

This must be considered in the re-construction process otherwise there may be adverse resulting forces imposed on the west and east walls.
